**ADAMS COUNTY HIGHWAY DEPARTMENT COMMITTEE**

# Final Report

## Pavement Investigation County Trunk Highway B from State Trunk Highway 82 to CTH E

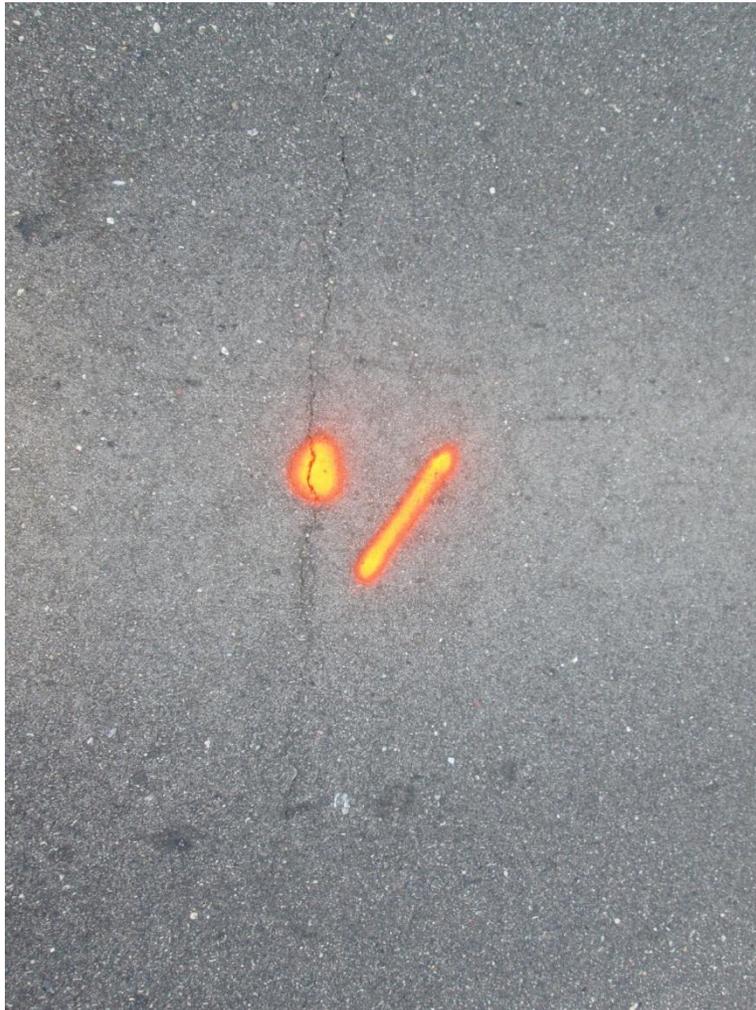
**Core 1 – Transverse Crack**

All eight cores taken on transverse or longitudinal cracks within both projects had a crack present in the underlying asphalt pavement. This indicates that the surface cracks are reflection cracks from the underlying asphalt pavement. In each of the cores, the crack sealing material was seen that the Adams County Maintenance crew placed prior to the overlay, which confirms that these cracks were present before the asphalt overlay was placed.

**51' SOUTH OF ADDRESS 2555 CTH B DRIVEWAY, 5' WEST OF CENTER LINE**

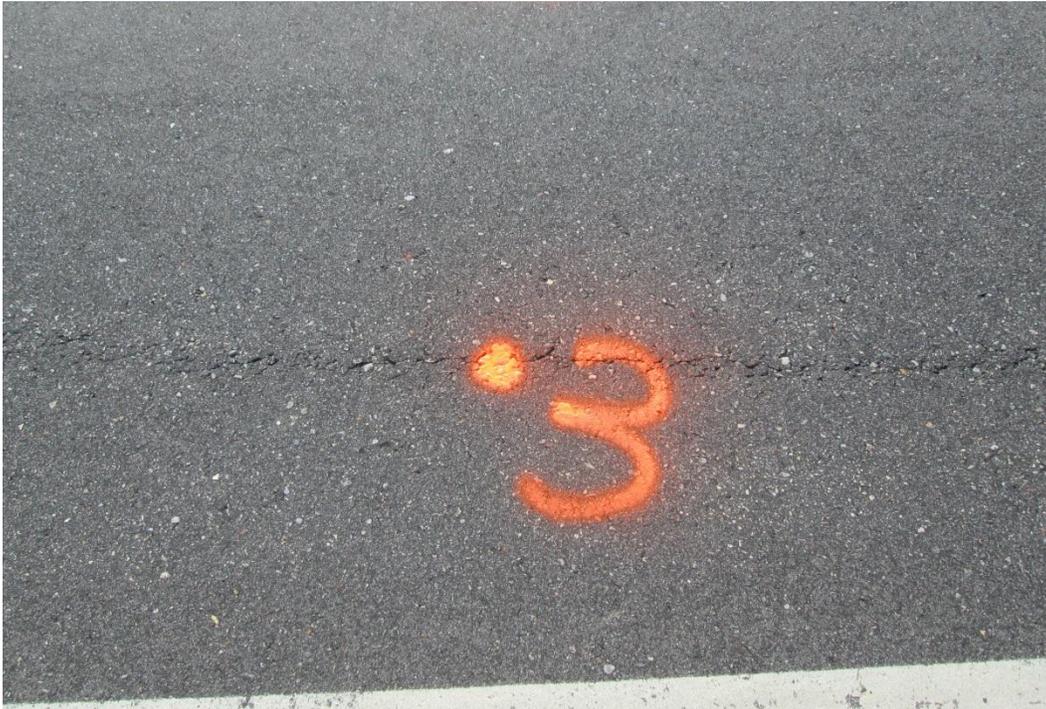
**Core 3 – Longitudinal Crack**

**757' NORTH OF EMBER AVENUE, 9' WEST OF CENTER LINE**

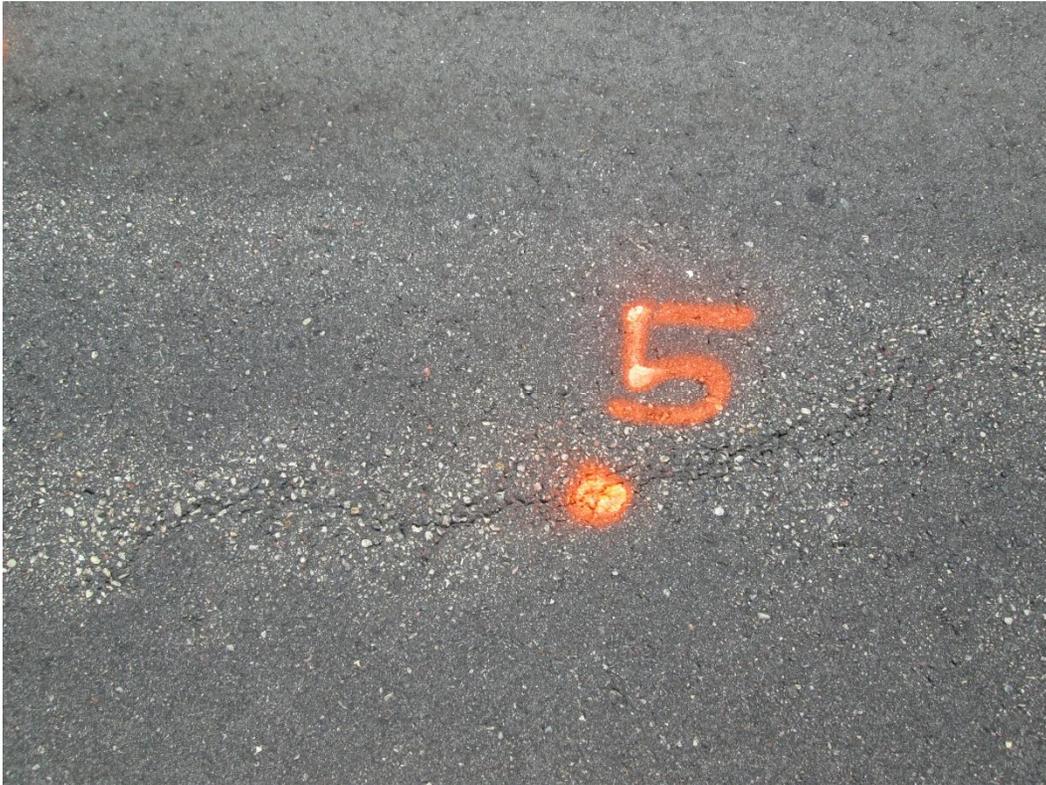
**Core 5 – Longitudinal Crack**

**78' SOUTH OF ADDRESS 3023 CTH B DRIVEWAY, 9' WEST OF CENTER LINE**

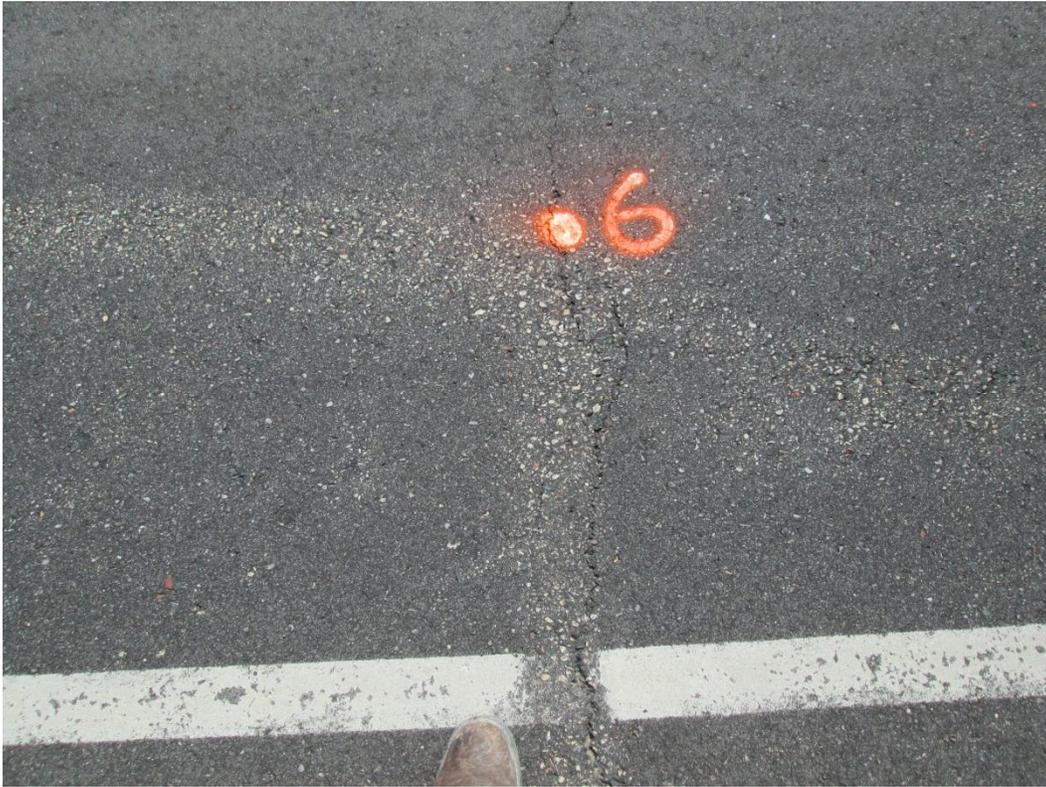
**Core 6 – Transverse Crack**

**68' SOUTH OF ADDRESS 3023 CTH B DRIVEWAY, 9' WEST OF CENTER LINE**

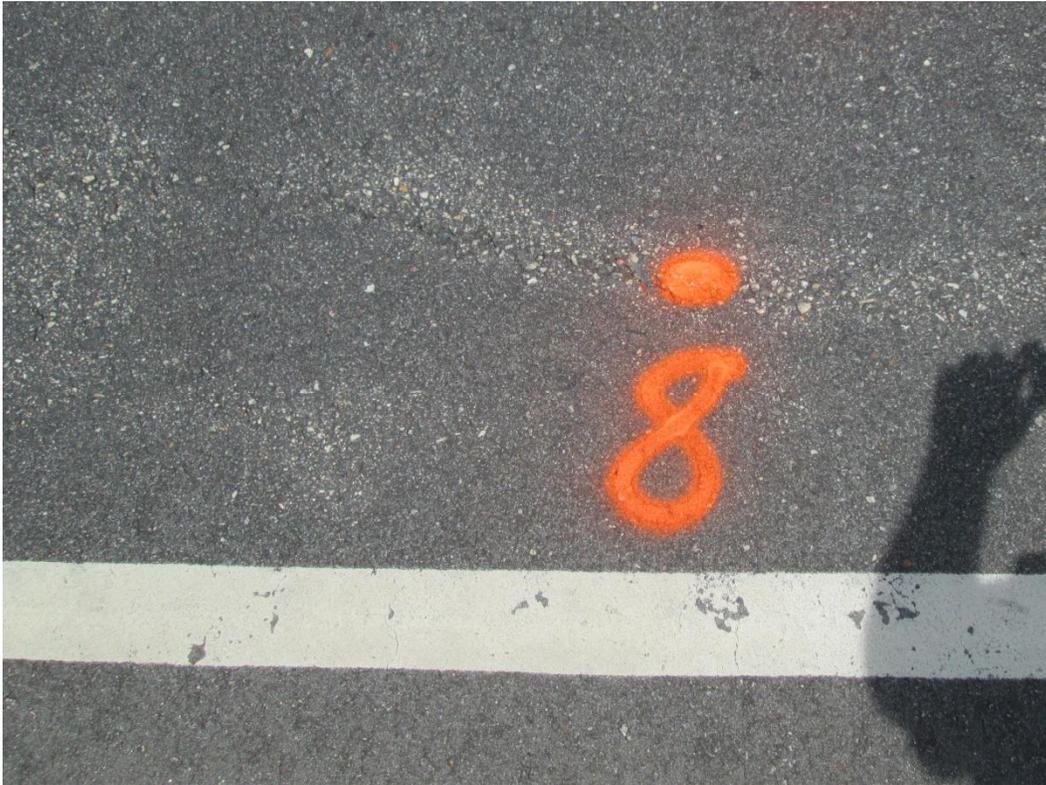
**Core 8 – Longitudinal Crack**

**63' NORTH OF ADDRESS 3164 CTH B DRIVEWAY, 10' EAST OF CENTER LINE**

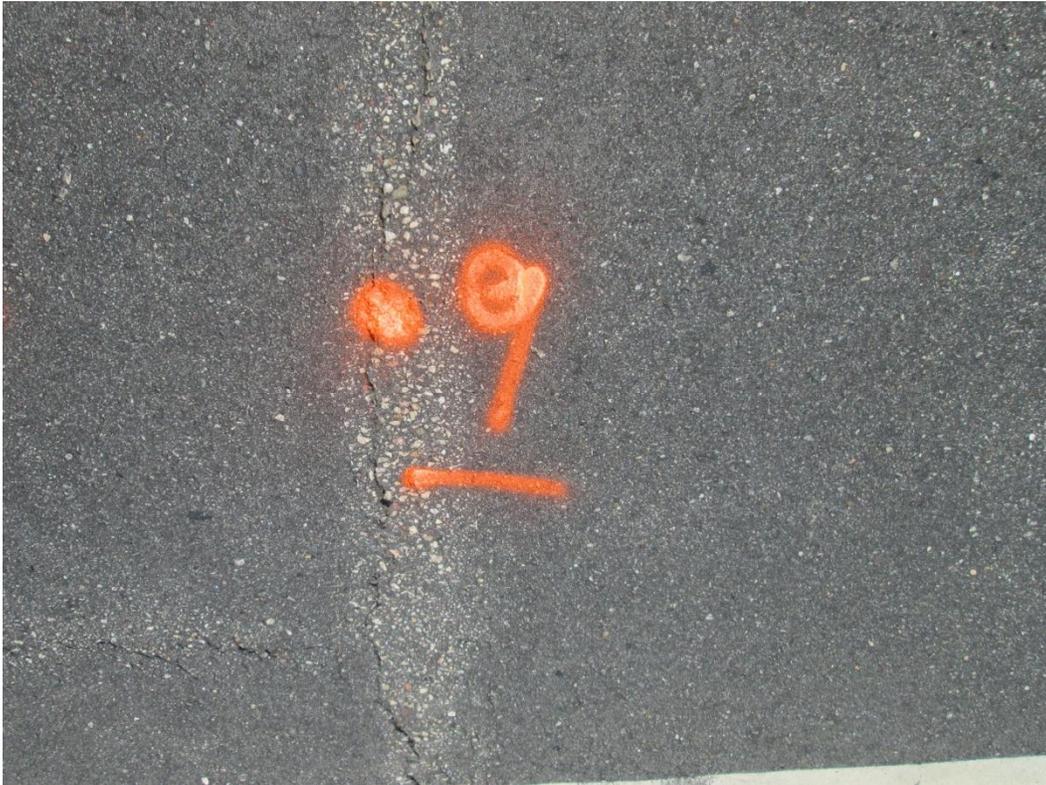
**Core 9 – Transverse Crack**

**67' NORTH OF ADDRESS 3164 CTH B DRIVEWAY, 8' EAST OF CENTER LINE**

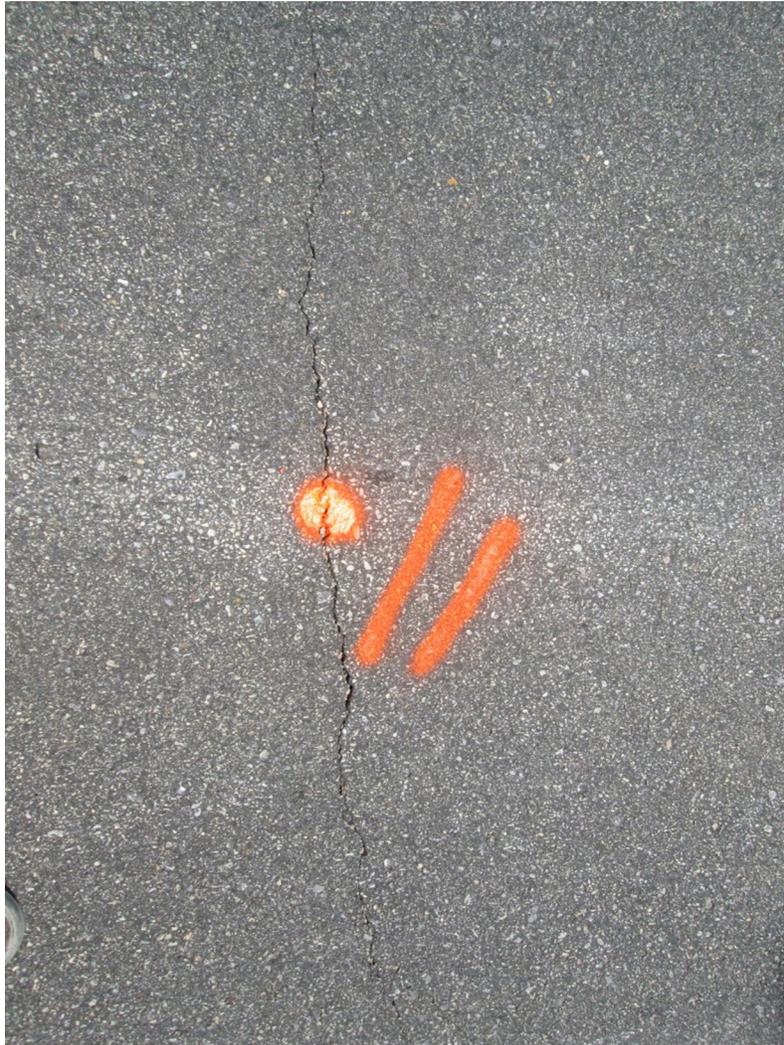
**Core 11 – Transverse Crack**

**311' NORTH OF FREEDOM AVENUE, 6' WEST OF CENTER LINE**

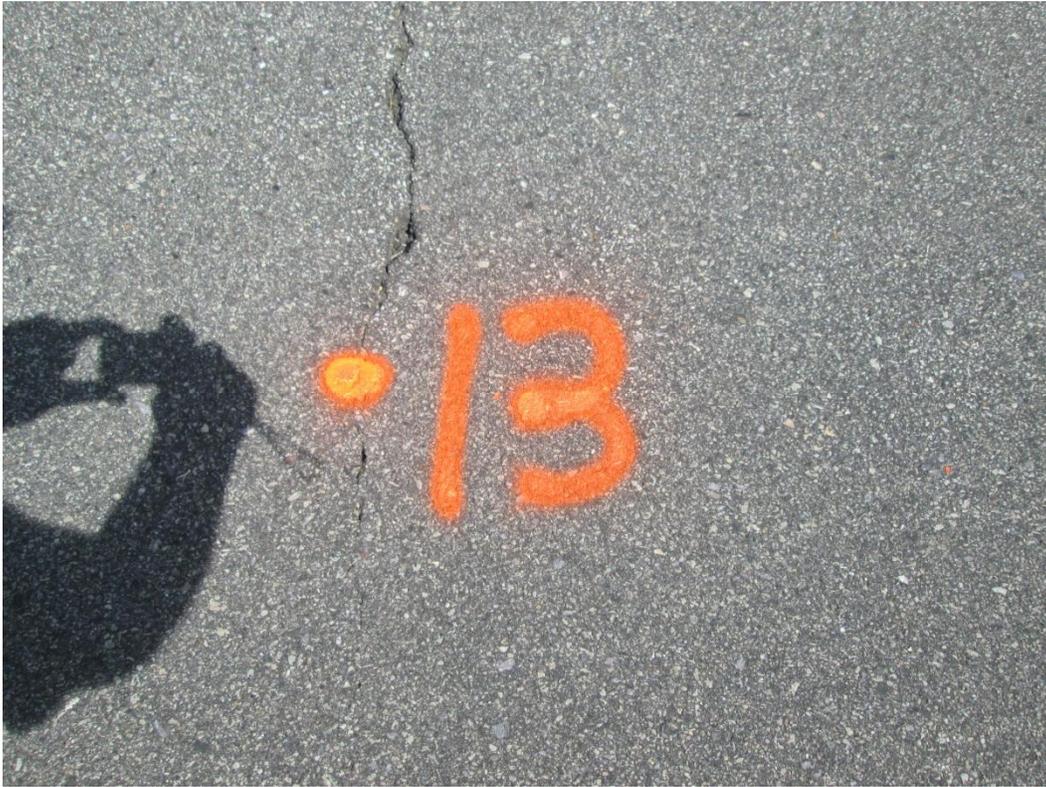
**Core 13 – Transverse Crack**

**98' SOUTH OF ADDRESS 3443 CTH B DRIVEWAY, 8' WEST OF CENTER LINE**

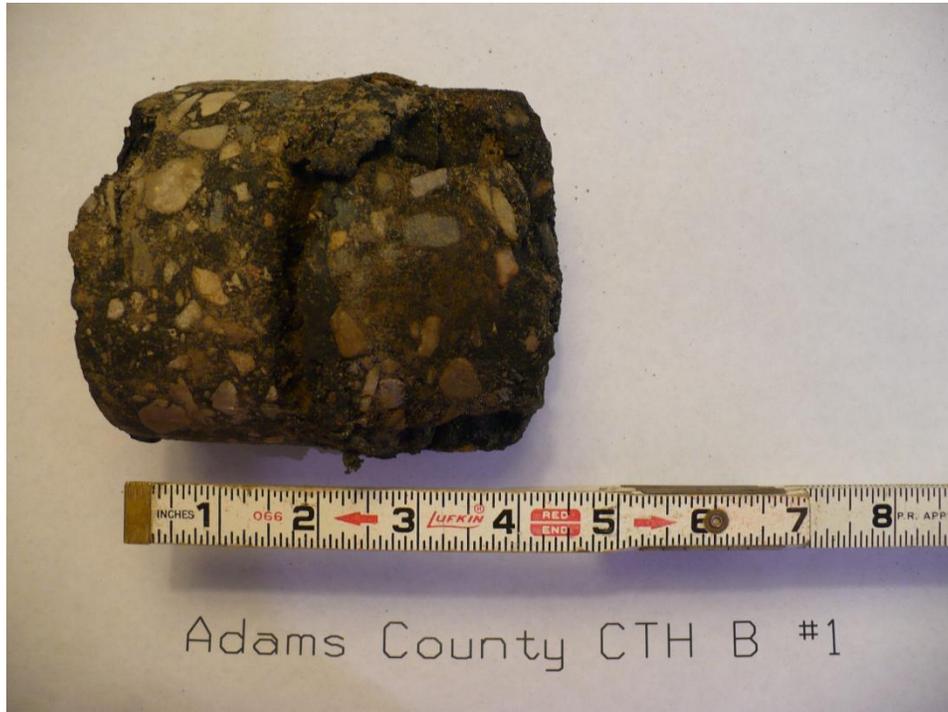
Core Number: 1

Comments: Core taken on transverse reflection crack. Good AC/AC

bond. Core broke during core extraction.

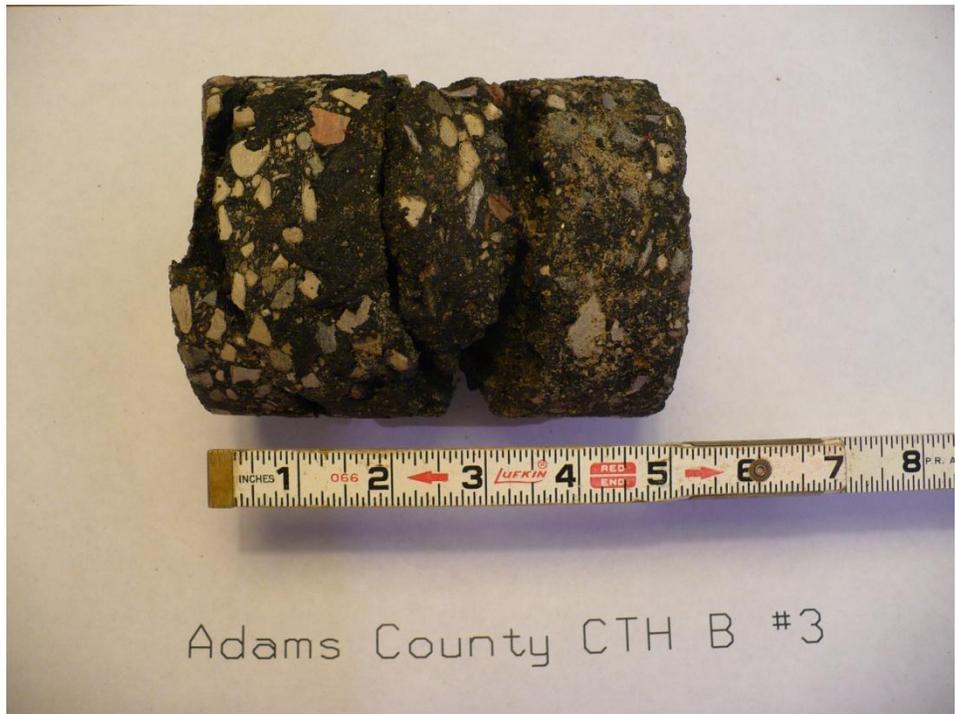
Core Number: 3

Comments: Core taken on longitudinal reflection crack. Good AC/AC

bond. Core broke during core extraction.

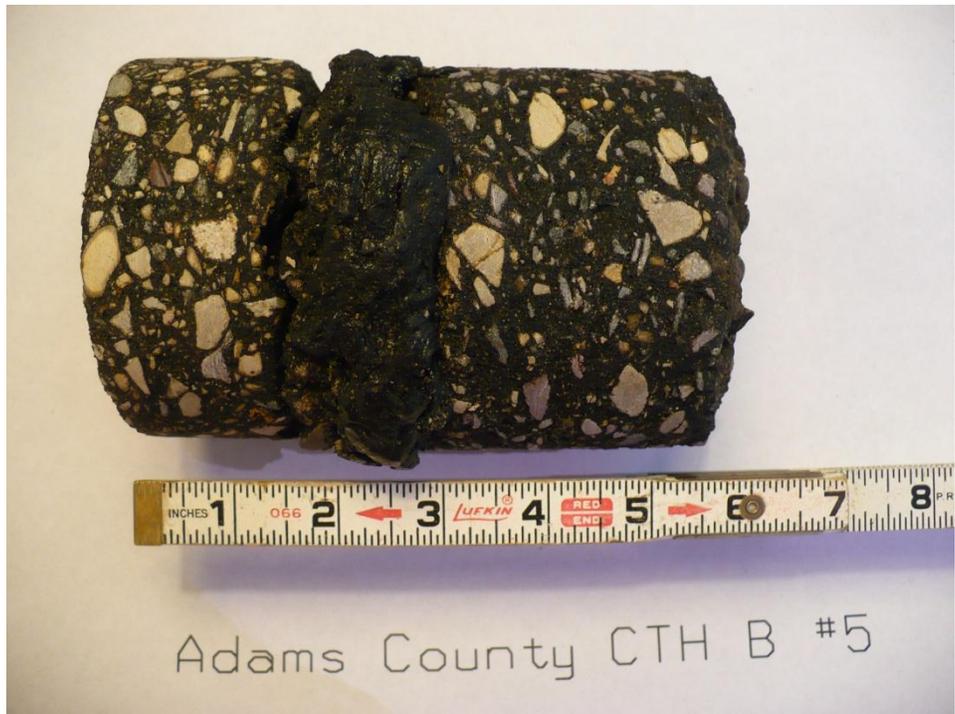
Core Number: 5

Comments: Core taken on longitudinal reflection crack. Good AC/AC

bond. Core broke during core extraction.

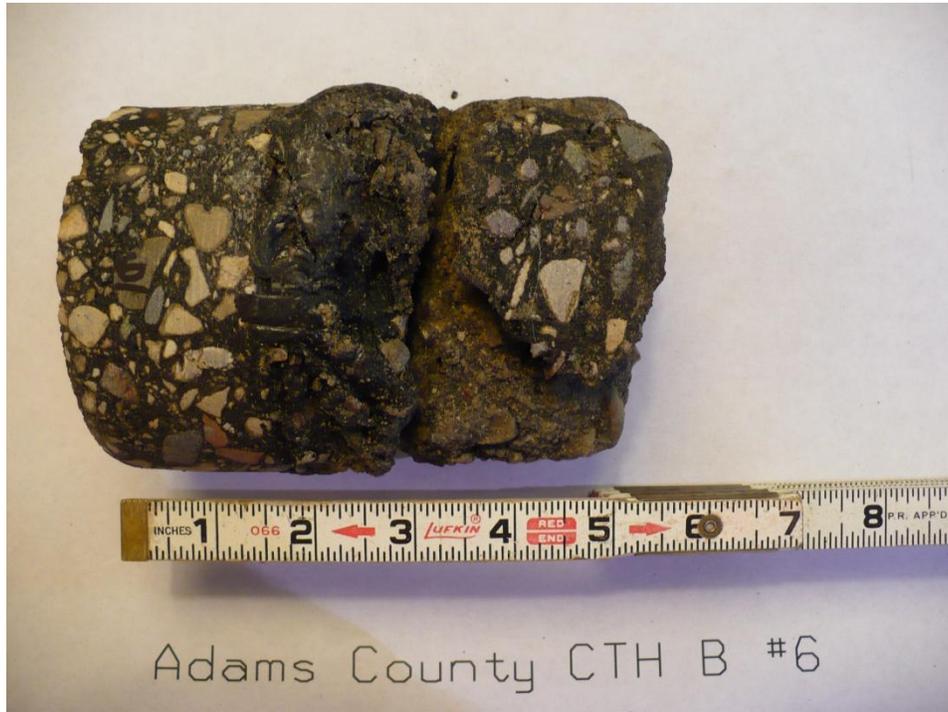
Core Number: 6

Comments: Core taken on transverse reflection crack. Good AC/AC

bond. Core broke during core extraction.

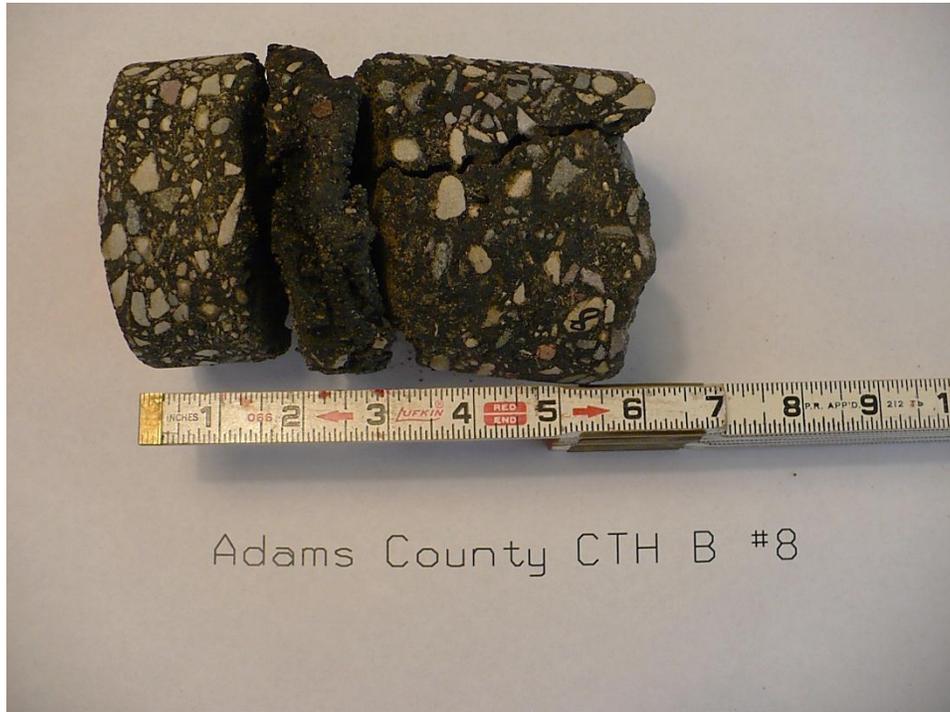
Core Number: 8

Comments: Core taken on longitudinal reflection crack. Good AC/AC

bond. Core broke during core extraction.

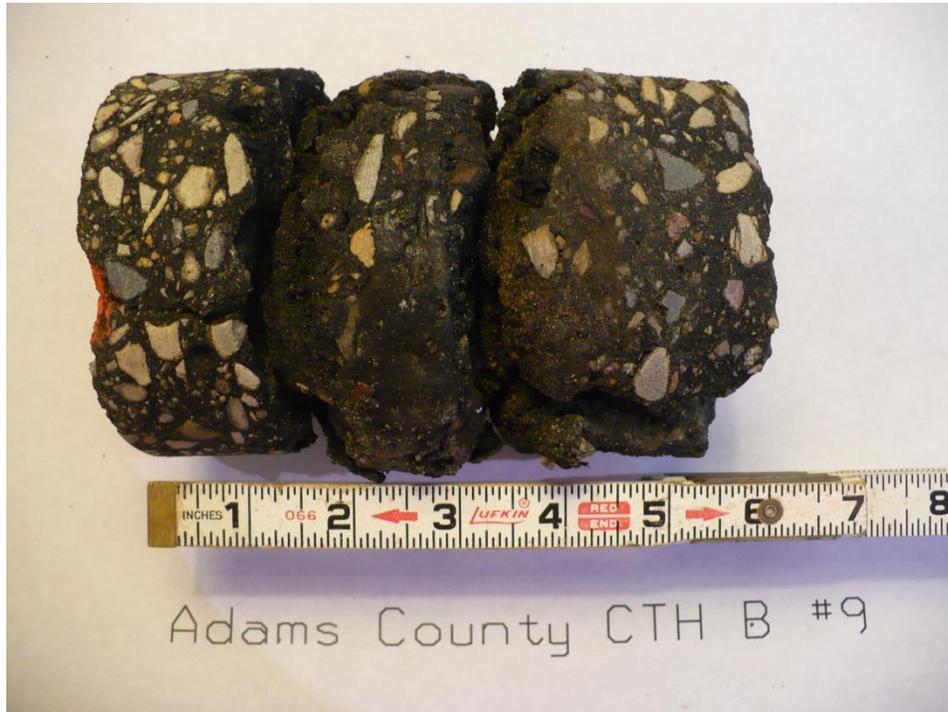
Core Number: 9

Comments: Core taken on transverse reflection crack. Good AC/AC

bond. Core broke during core extraction.

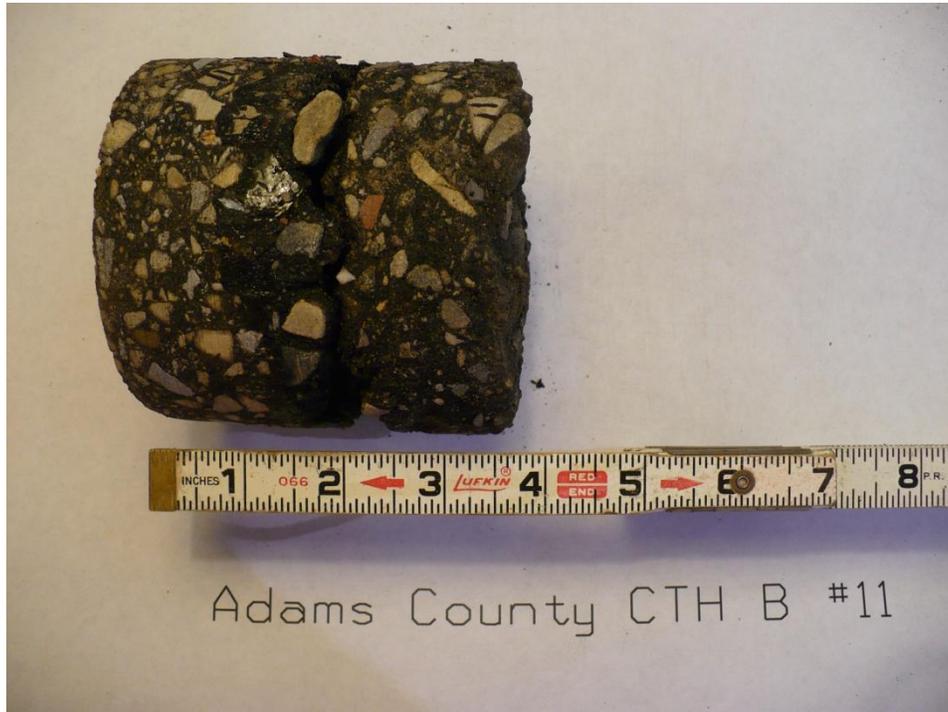
Debond at  
AC/AC interface

Comments: Core taken on transverse reflection crack. Slight debond  
at AC/AC interface.

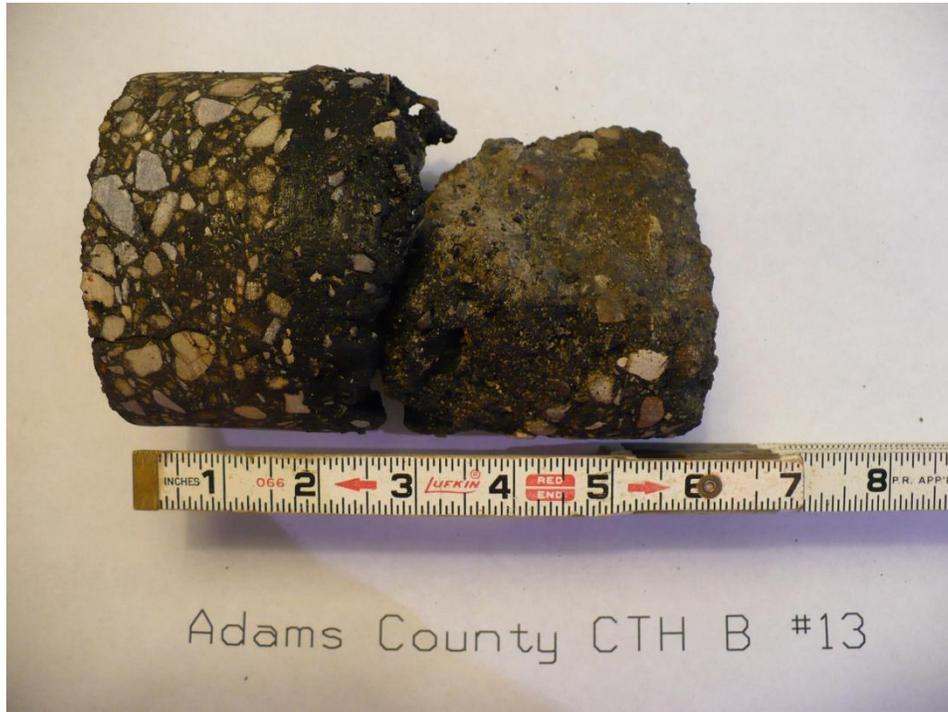
Comments: Core taken on transverse reflection crack. Good AC/AC

bond. Core broke during core extraction.
