**ADAMS COUNTY HIGHWAY DEPARTMENT COMMITTEE**

# Final Report

## Pavement Investigation County Trunk Highway B from State Trunk Highway 82 to CTH E

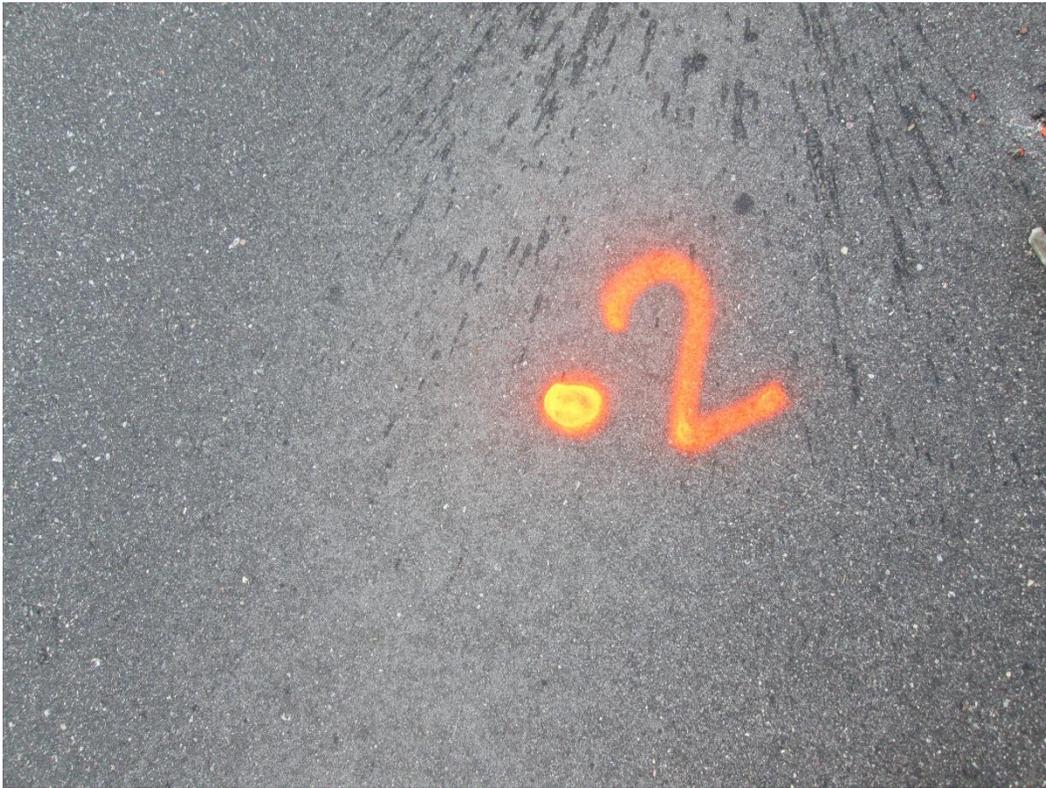
**Core 2**

**56' SOUTH OF ADDRESS 2555 CTH B DRIVEWAY, 5' WEST OF CENTER LINE**

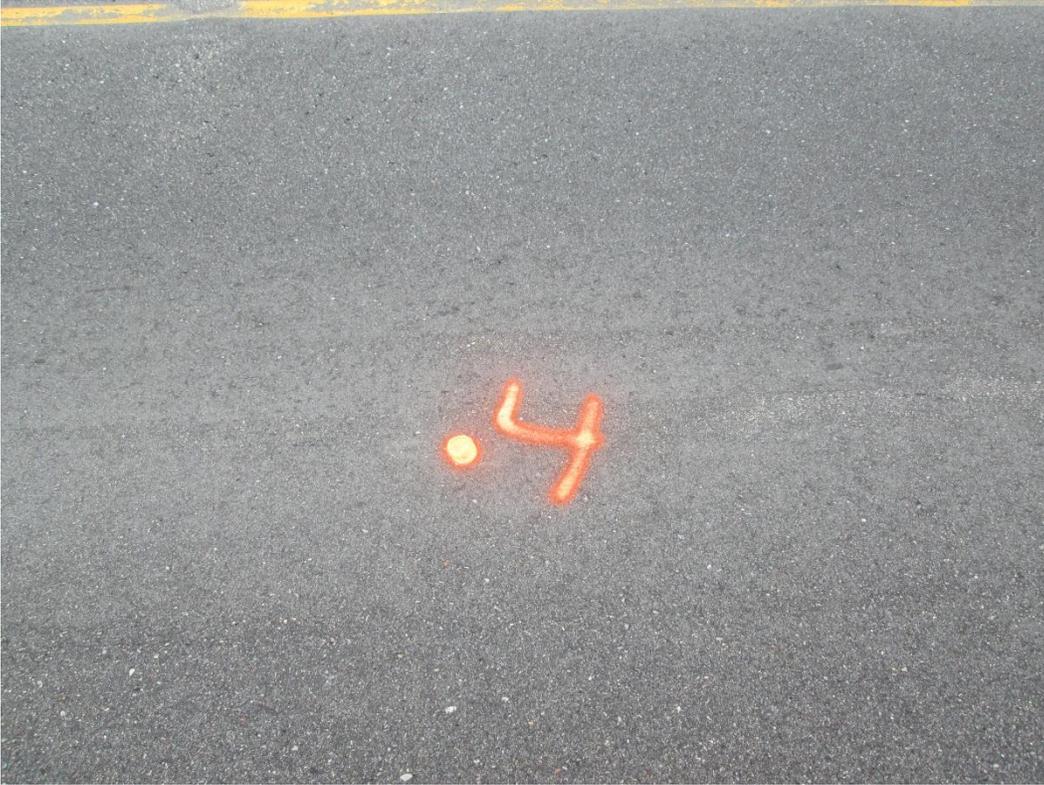
Core 4

757' NORTH OF EMBER AVENUE, 6' WEST OF CENTER LINE

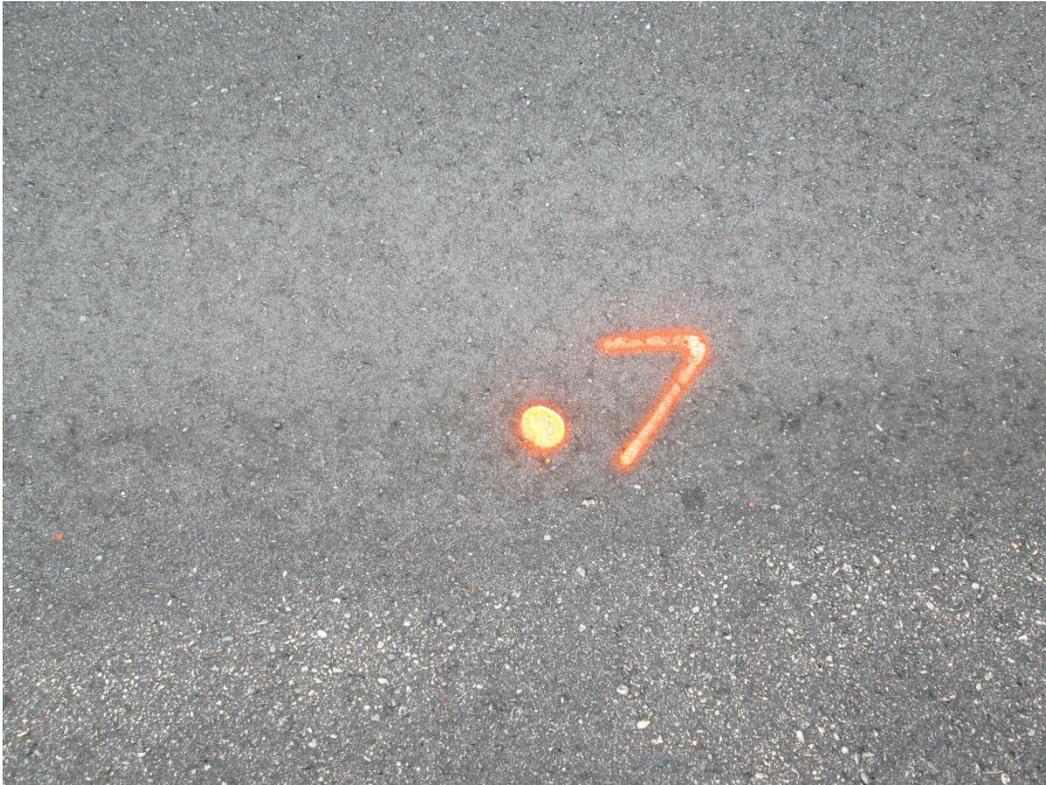
**Core 7**

**73' SOUTH OF ADDRESS 3023 CTH B DRIVEWAY, 7' WEST OF CENTER LINE**

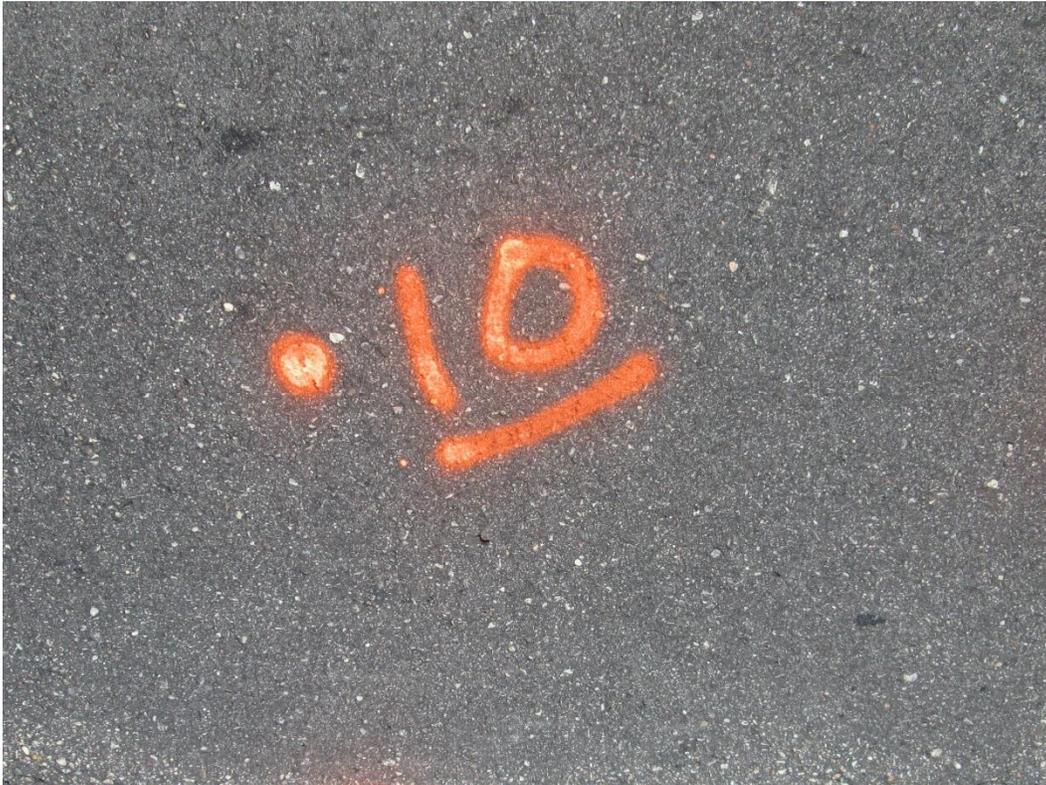
**Core 10**

**63' NORTH OF ADDRESS 3164 CTH B DRIVEWAY, 8' EAST OF CENTER LINE**

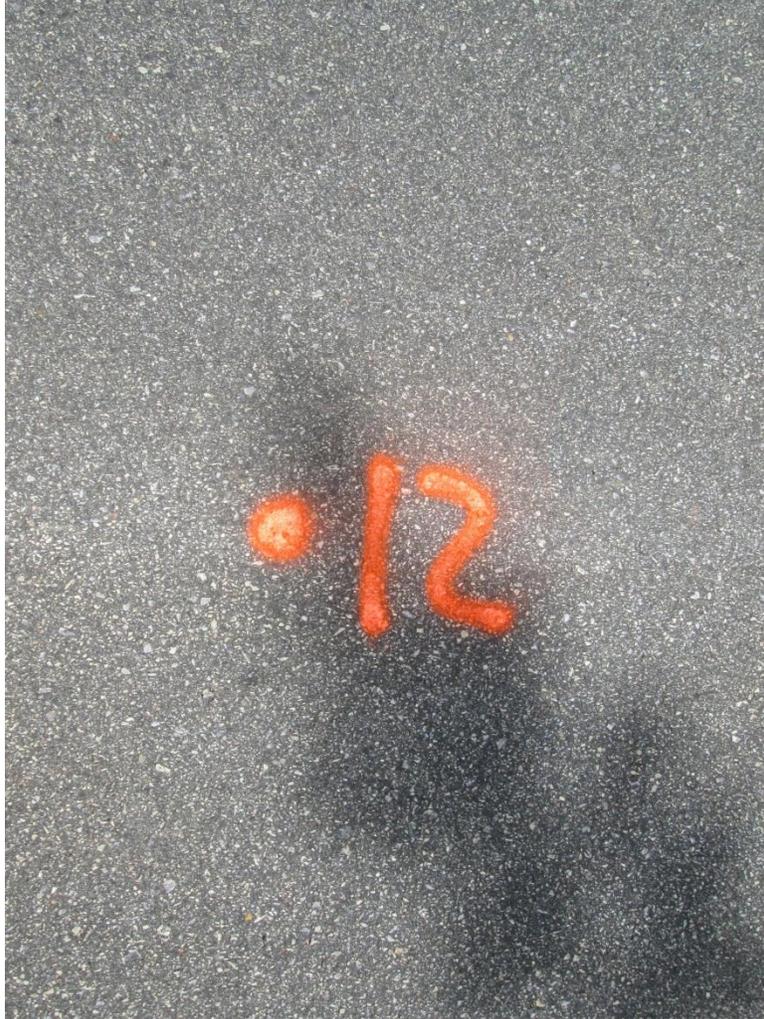
Core 12

308' NORTH OF FREEDOM AVENUE, 6' WEST OF CENTER LINE

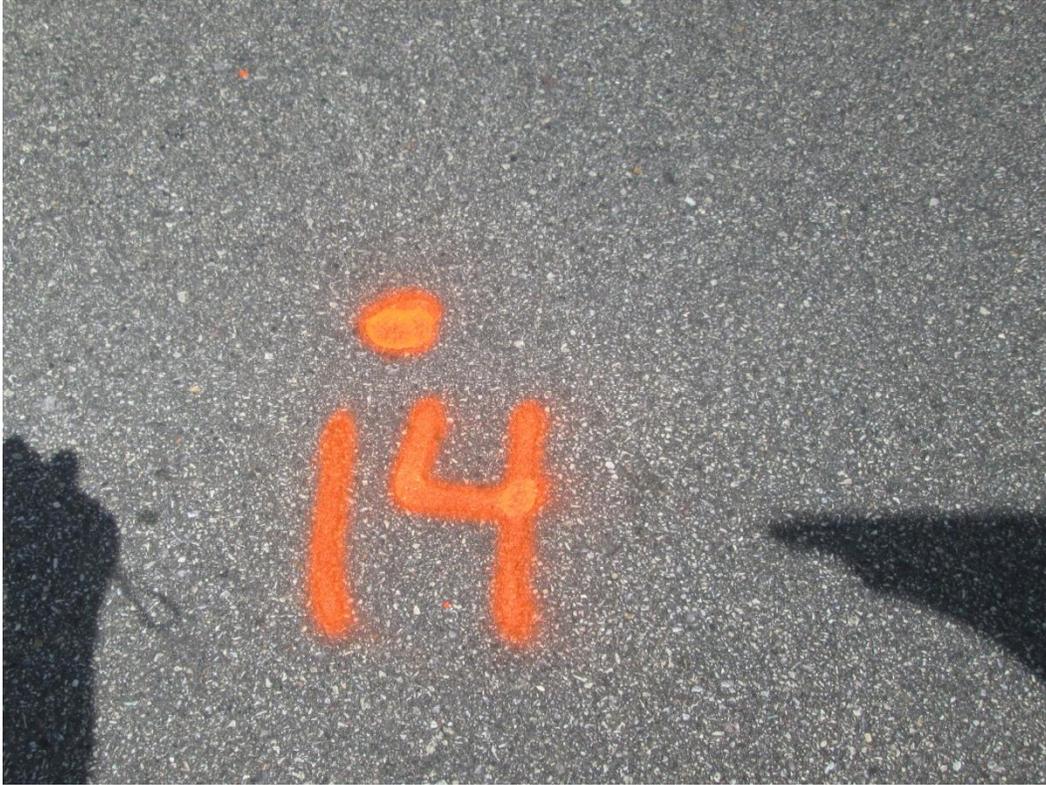
**Core 14**

**105' SOUTH OF ADDRESS 3443 CTH B DRIVEWAY, 4' WEST OF CENTER LINE**

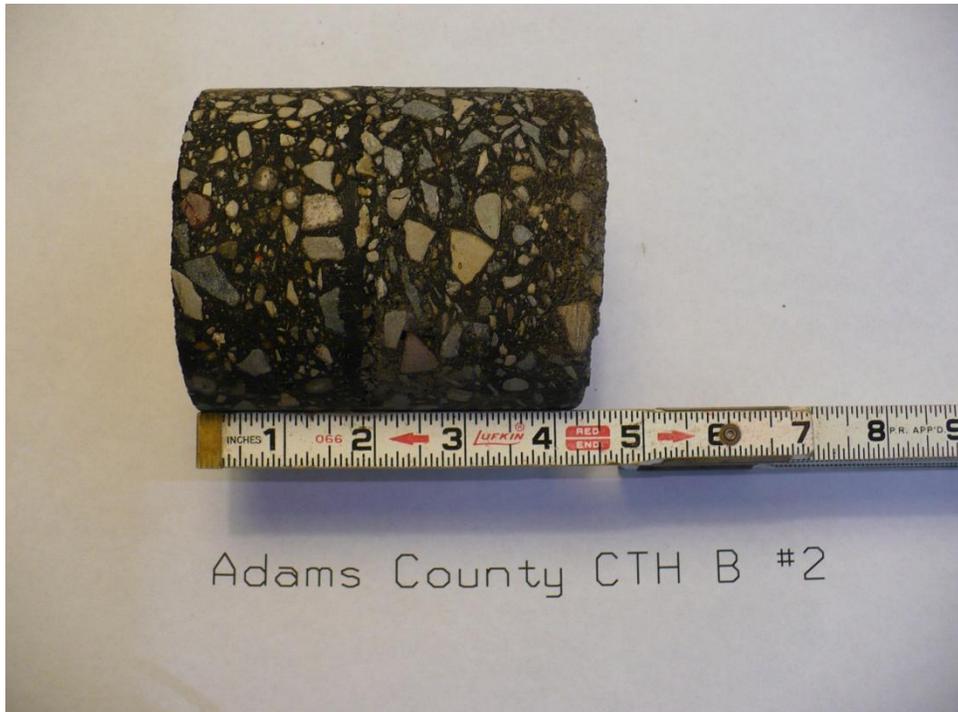
Comments: Core taken on transverse reflection crack. Good AC/AC

bond. Core broke during core extraction.

1-3/4" AC  
Overlay

2-1/2" AC

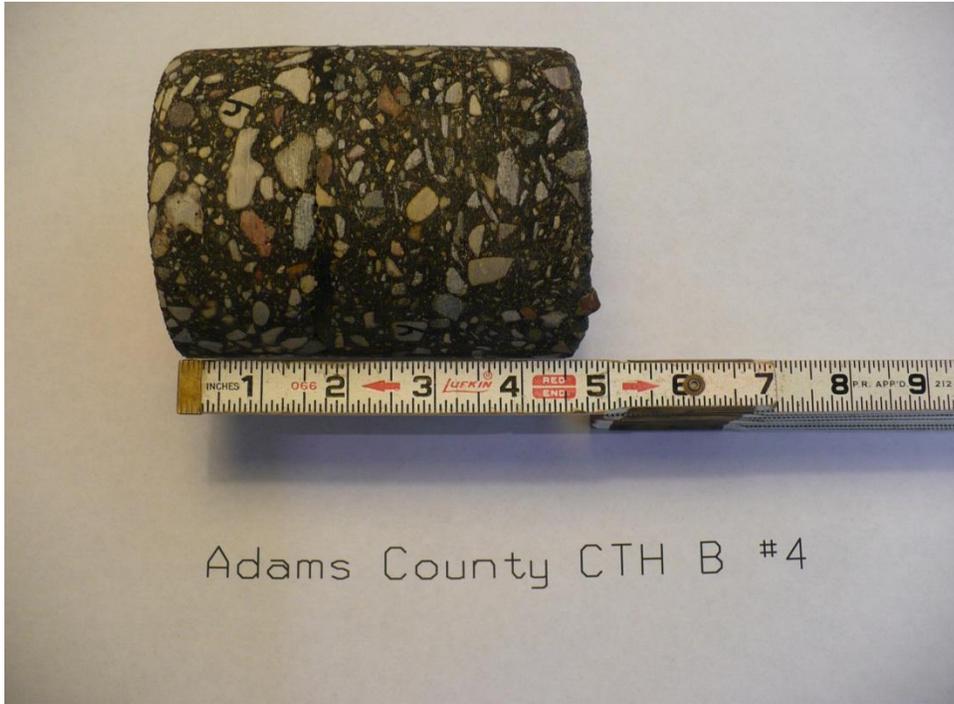
Comments: Core taken on longitudinal reflection crack. Good AC/AC

bond. Core broke during core extraction.

2" AC  
Overlay

2 1/2" AC

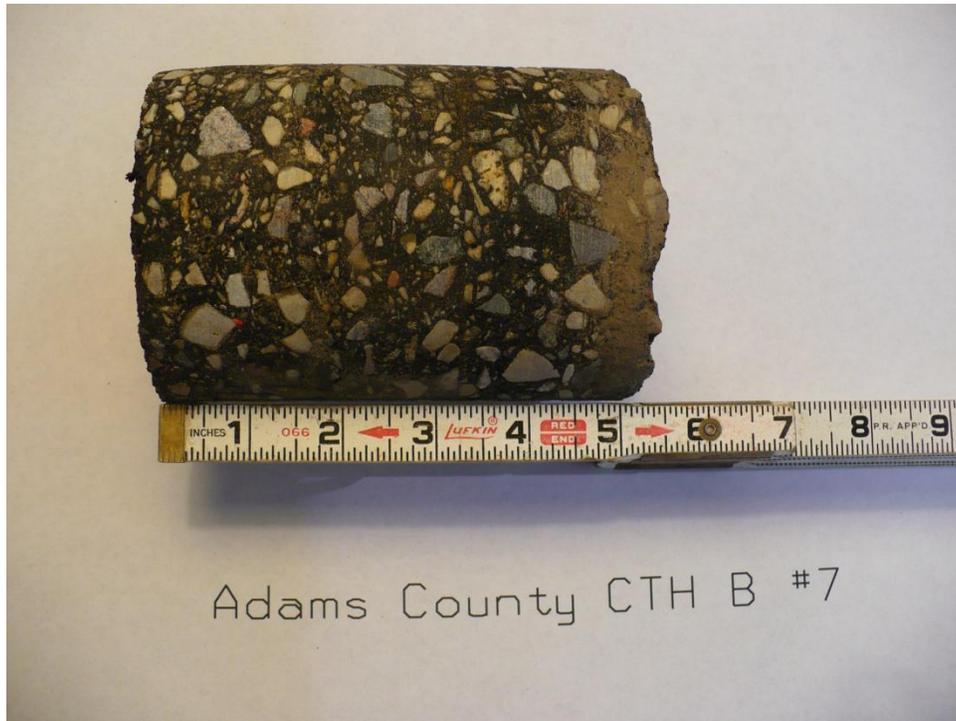
Comments: Core taken on transverse reflection crack. Good AC/AC

bond. Core broke during core extraction.

2" AC  
Overlay

3-1/4" AC

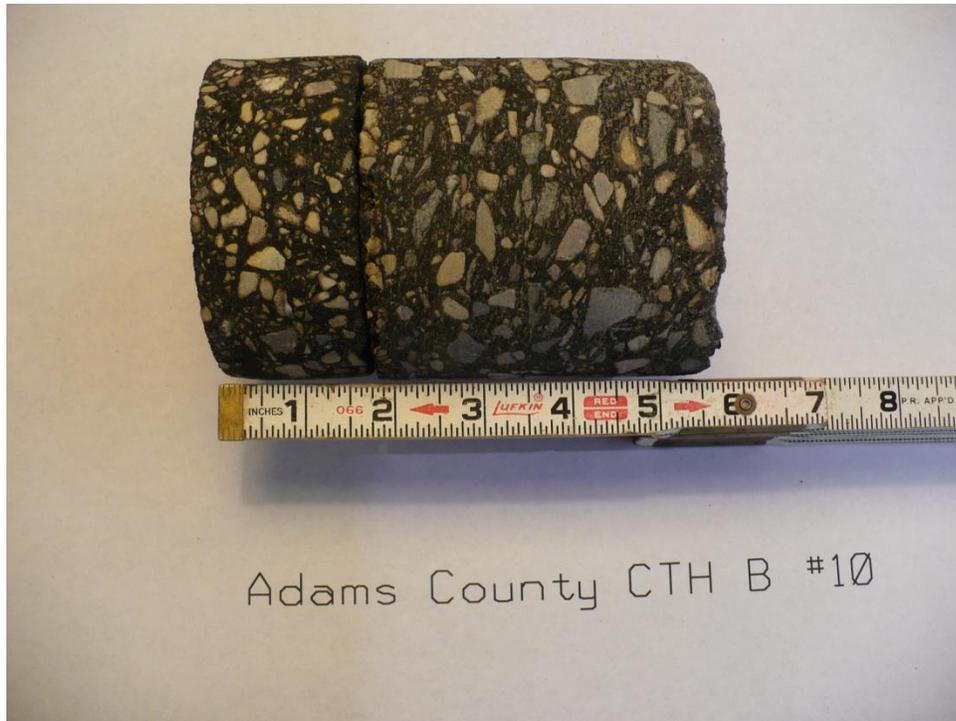
Comments: Core taken on transverse reflection crack. Good AC/AC

bond. Core broke during core extraction.

1-5/8" AC  
Overlay

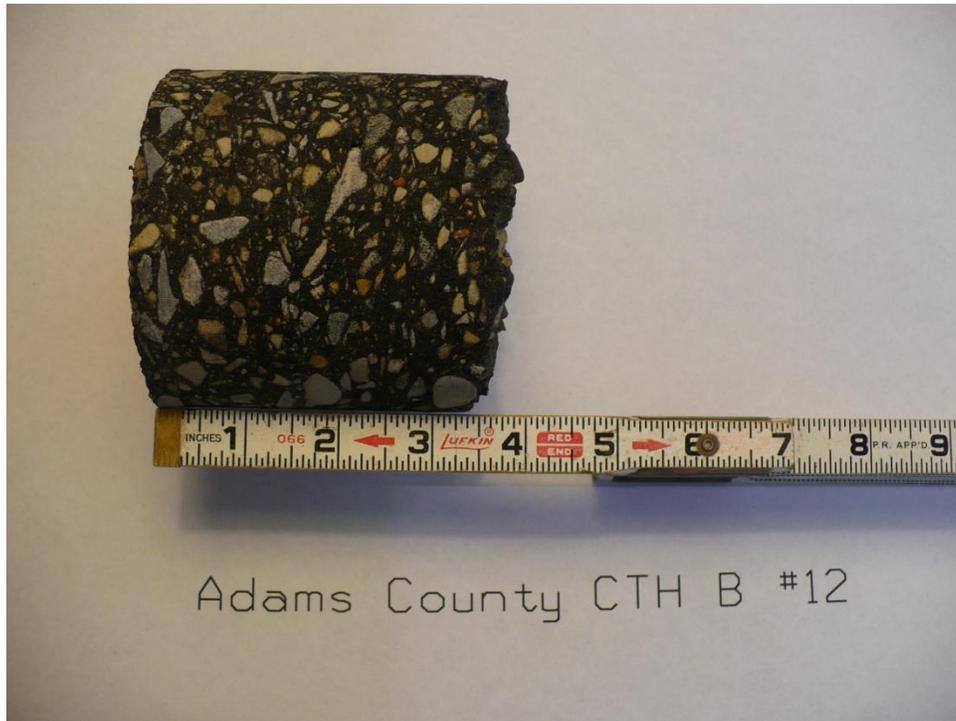
Comments: Core taken on transverse reflection crack. Slight debond  
at AC/AC interface.

1-5/8" AC  
Overlay

1-7/8" AC

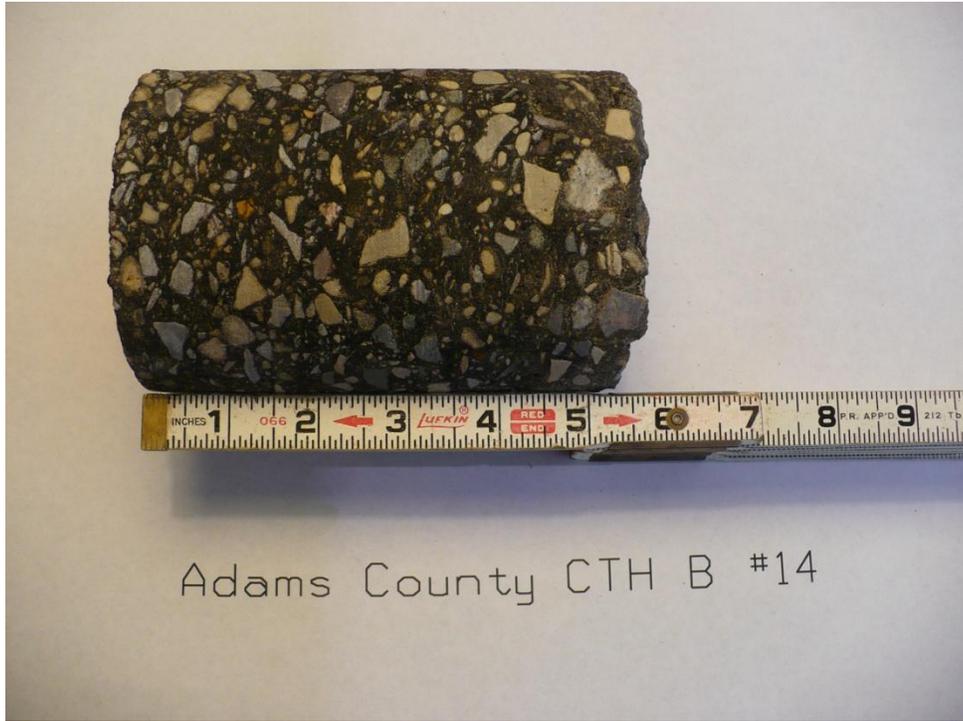
Comments: Core taken on transverse reflection crack. Good AC/AC

bond. Core broke during core extraction.

2" AC Overlay	Date:	7/2/2013
		Core Number:	14
	3-3/8" AC	Core Location:	105 Feet South of Address 3443 CTH B Driveway
			Offset: 4 Feet West of Center Line
		Core Length:	5-3/8" Total
		Comments:	Asphalt testing was performed on this core.
